ROY DAVIS DAM

REYNOLDS COUNTY, MISSOURI

PHASE 1 INSPECTION REPORT

ROY DAVIS DAM
REYNOLDS COUNTY, MISSOURI
MISSOURI INVENTORY NO. 30056

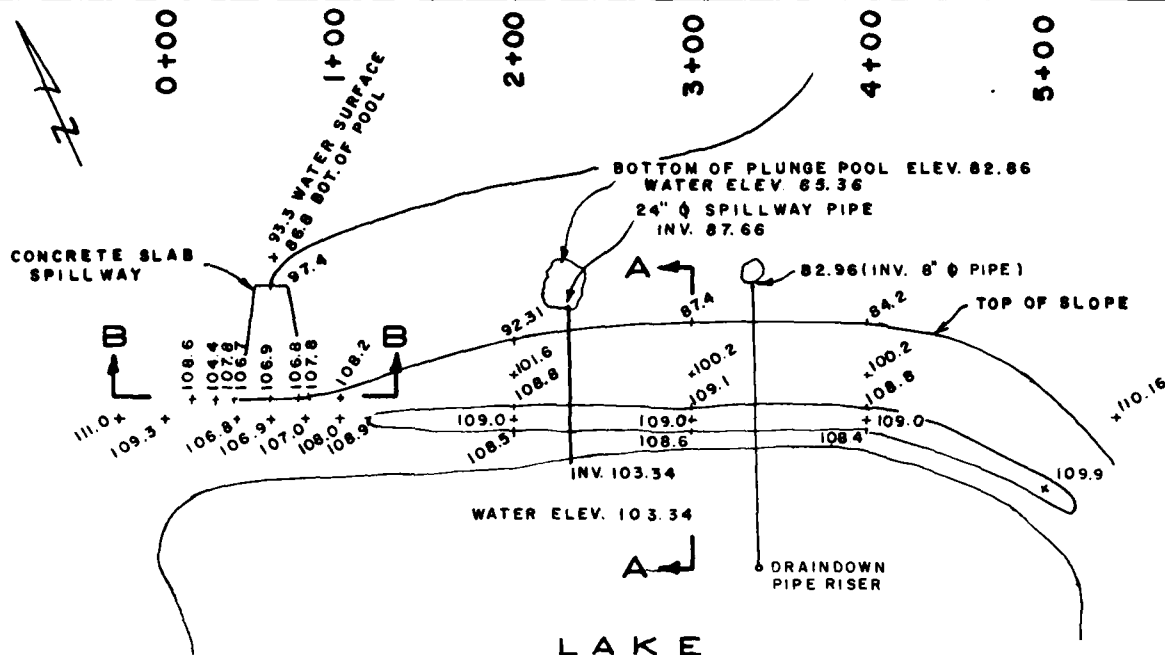
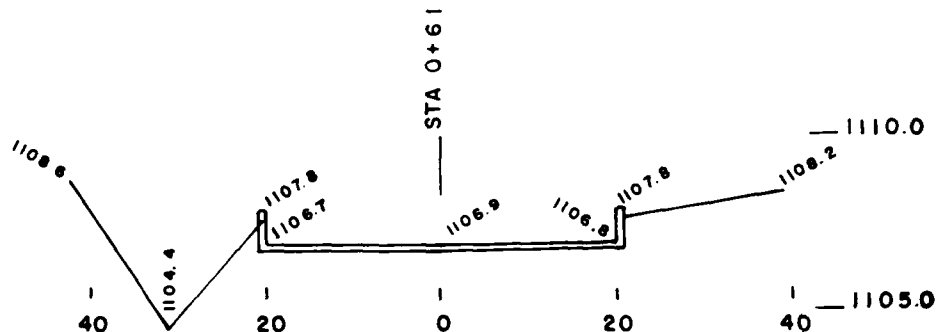
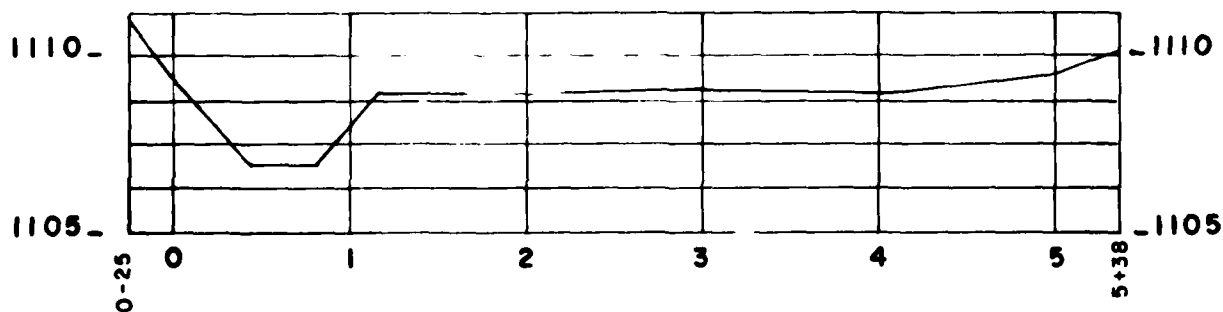
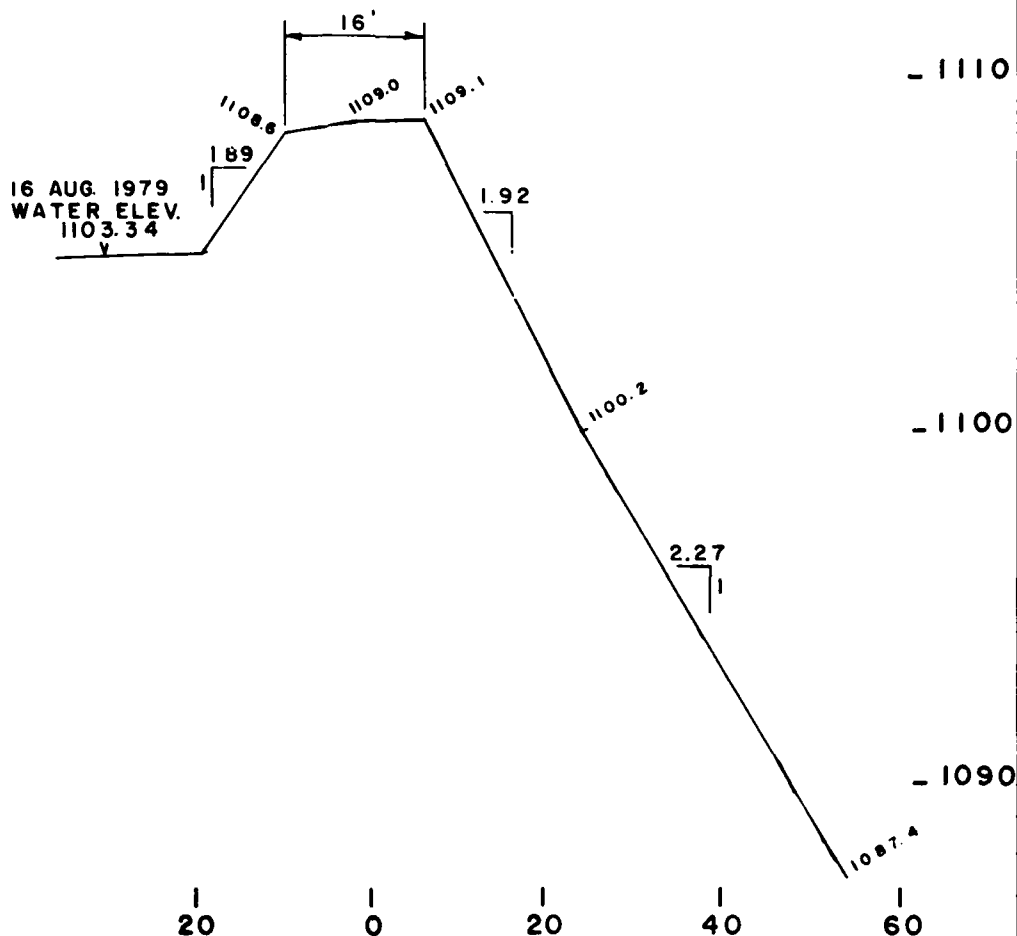
SHEET 3 OF APPENDIX A

The emergency spillway has a concrete lining (see sheet 3 of Appendix A for details). The concrete appears to be in good condition. The end of the concrete chute has undermined about 1 1/2 ft. The approach to the spillway is clear as is the discharge channel. The emergency spillway has been used several times. According to Mr. Roy Davis the most water through the spillway occurred this spring when the water was up to the side walls of the concrete lining (approximately 12 in. over the spillway).

- (4) The logs and debris should be cleared from around the inlet to the primary spillway.
- (5) Repair of erosion under the end of the emergency spillway lining and installation of an end wall to prevent future erosion.
- (6) The trash rack should be repaired and perhaps modified so that it will not allow debris to get to the pipe inlet.
- (7) A detailed inspection of the dam should be made periodically by an engineer experienced in the design and construction of dams.

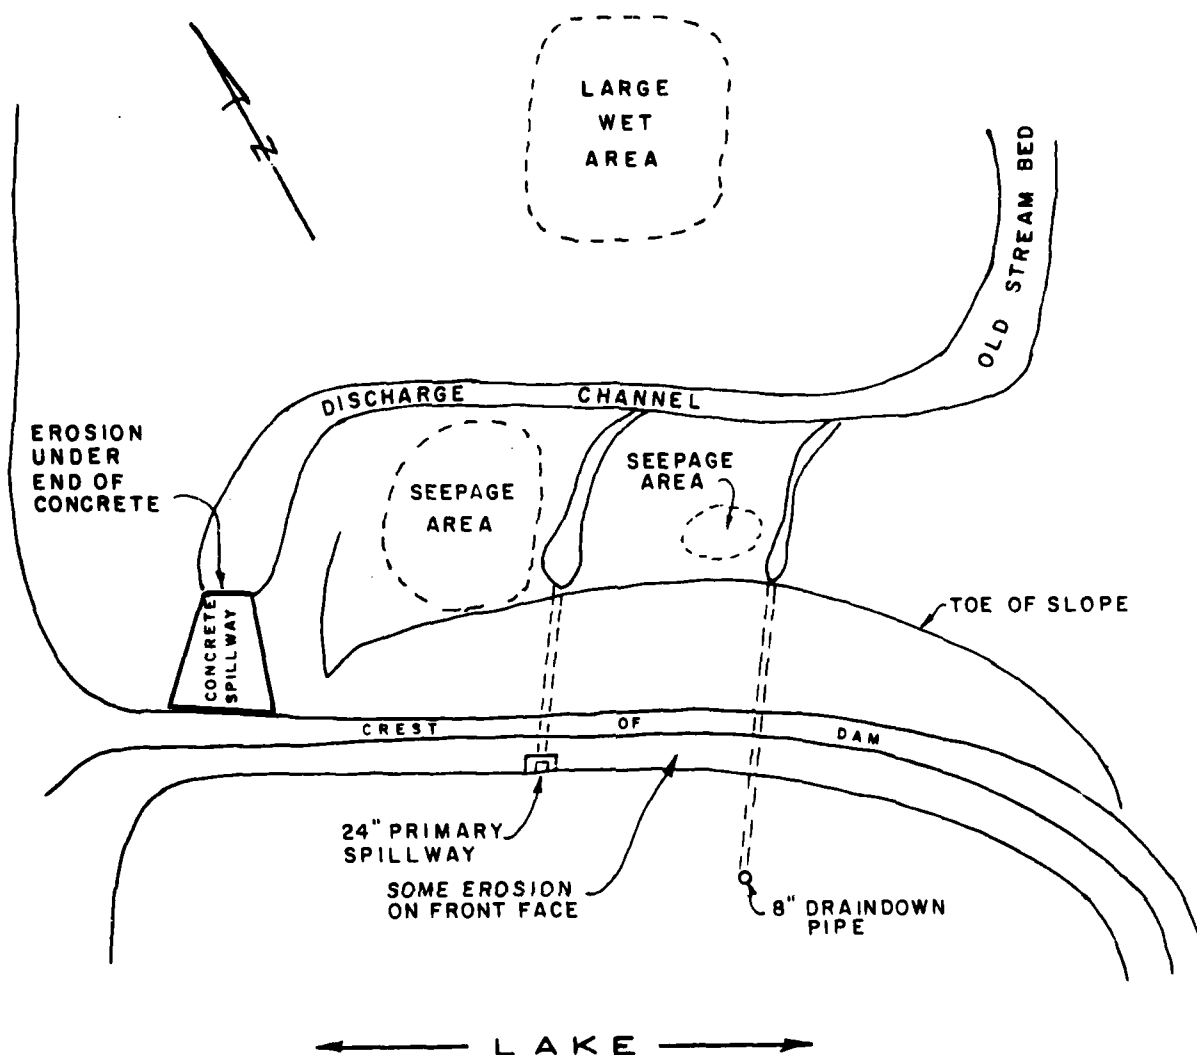
PLAN SKETCH
INSPECTION OBSERVATION
DAM No. MO. 30056

There are two apparent areas of seepage at the downstream toe. The areas are to the west of the 8 in. drawdown pipe outlet and to the west of the 24 in. primary spillway pipe (See sheet 4, Appendix A). The apparent seepage is manifested by wet, soft ground, cattails, and small pools of water with iron staining. No flow of water could be observed in either of these areas. The valley downstream of the dam (300 ft. past dam) has several areas of standing water and cattail growth. This wet area in the valley could be due to drainage from the hillside.
